# 1-10 Cambridge Gate

## Condition Report

#### Cleaning Test Results

Report prepared for:  
**Crown Estate Paving  
Commission**

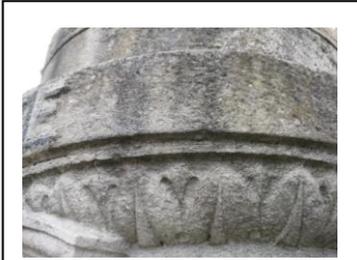
<p><b>Monument 3, west elevation</b></p>	<p>5% prediluted Synperonic A7 in deionised water. Used in conjunction with denture brushes.</p>	<p>Biological and pollution</p>	<p>N/A</p>	<p>10°C, cloudy with heavy rain showers</p>	<p>Effective at removing light biological and pollution staining.</p>	<div style="display: flex; flex-wrap: wrap;"> <div style="width: 50%; text-align: center;">

<p>Before cleaning.</p> </div> <div style="width: 50%; text-align: center;">

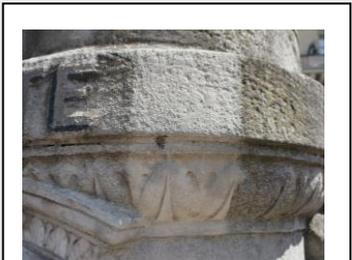
<p>After cleaning.</p> </div> <div style="width: 50%; text-align: center;">

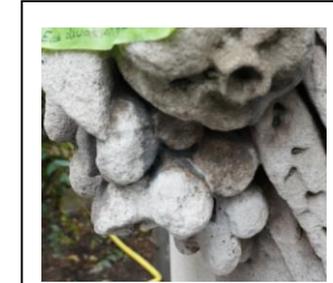
<p><b>Monument 3, east elevation</b></p>	<p>Complex Paste 3. Manufacture (restorative techniques). Paste removed with deionised water and denture brushes.</p>	<p>Sulphation and pollution</p>	<p>60 minutes. Checked every 10 minutes.</p>	<p>10°C, cloudy with heavy rain showers</p>	<p>Reduced the staining but a pinkish brown staining became more evident.</p>

<p>After cleaning.</p>
<p><b>Monument 3, north elevation</b></p>	<p>Monumentique paste Manufacturer: Restorative techniques</p>	<p>Sulphation</p>	<p>6-16 hours</p>	<p>10°C, cloudy with heavy rain showers</p>	<p>1<sup>st</sup> application, 6 hours: Successfully removed most of the staining with some small residues remaining. 2<sup>nd</sup> application, 16 hours: Successfully removed most of the staining with some small residues remaining and some faint pinkish residue</p>

Complex pastes 1 and 2 were not effective on removal of the sulphation crusts and can be discounted for use on the limestone sections of the monument.

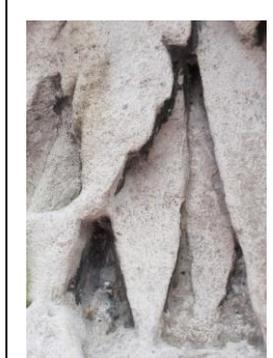
<p><b>Monument</b> 3, east elevation</p>	<p>10% ammonium carbonate poultice with Sepiolite and Arbocel®</p>	<p>Thick sulphation</p>	<p>16 hours and</p>	<p>10°C, cloudy with heavy rain showers</p>	<p>The staining was only slightly reduced. The sulphation did soften slightly but it was difficult to remove without eroding the limestone surface.</p>

<p>After 2<sup>nd</sup> application.</p>

10% Ammonium Carbonate in a Sepiolite and Arbocel poultice was tested in two areas. It did not remove the sulphation on one area, but softened it and removing it was found to erode the stone. On the second test with 2 applications, it removed sulphation but not entirely
